Building Number: 203

Original Name: Family Housing with Garage

Est. Year of Construction: 1959

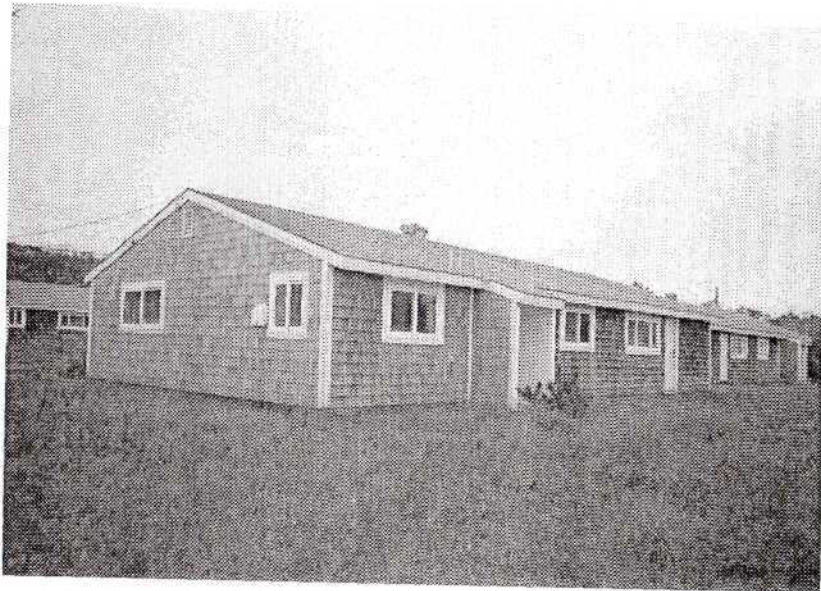
View from northeast.

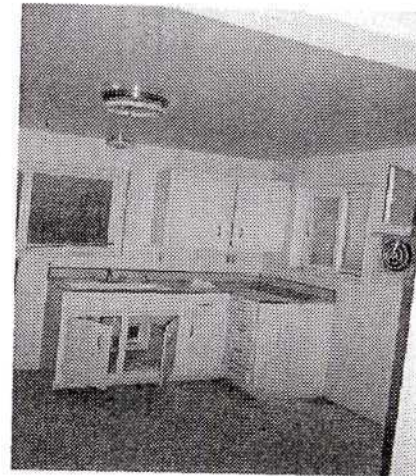
Interior - kitchen.

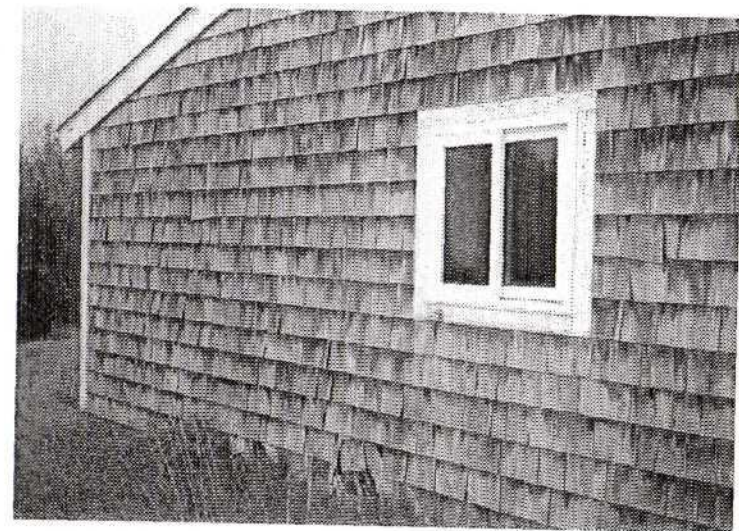
View of west elevation – note accelerated weathering at this exposure.

- *Roof*
Asphalt shingle roof in **fair condition**. Sheet metal chimney painted with brick trompe d'oeil in fair condition. Vent above bathroom light flaps in wind.
- *Wall*
Exterior sheathed in white cedar shingles is in **fair/ poor condition**. Recommend replacement of 200 SF.
- *Trim*
Painted wood trim in **poor condition**. Needs repair at front portico and rotted corners. Recommend replacement of 50 LF. Soffits in fair condition.
- *Foundation*
Poured concrete slab on grade in **good condition**.
